### 3.2.6. Exterior Walls

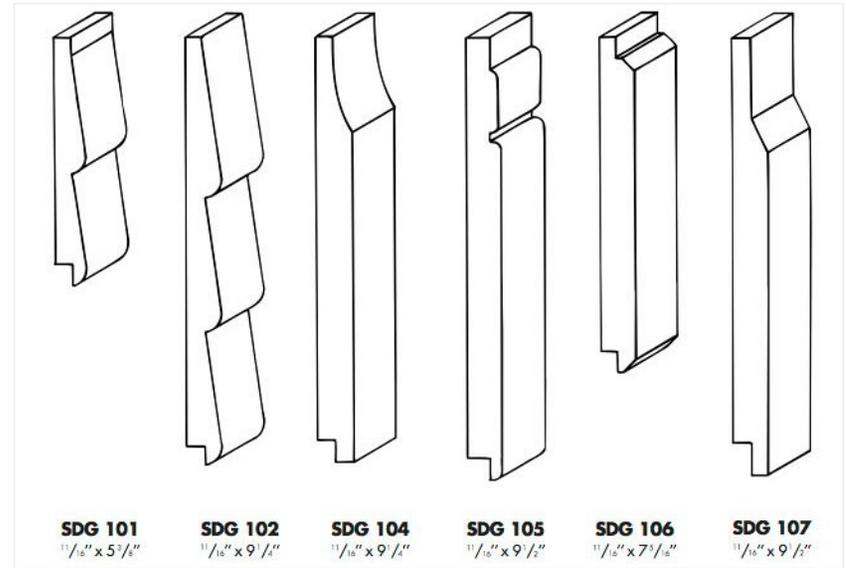
Figure 3-24. Examples of common siding dimensions, to be matched as closely as possible. Source: "Choosing the Siding is Half the Battle," *Old Town Home*, updated July 22, 2013, <https://www.oldtownhome.com/2013/7/22/Choosing-the-Siding-is-Half-the-Battle>.

- (j) If replacement of historic exterior wall materials is necessary, choose a material identical in dimensions, profile, reveal, and texture to the historic material as closely as possible given available options (SOI Standard 6).

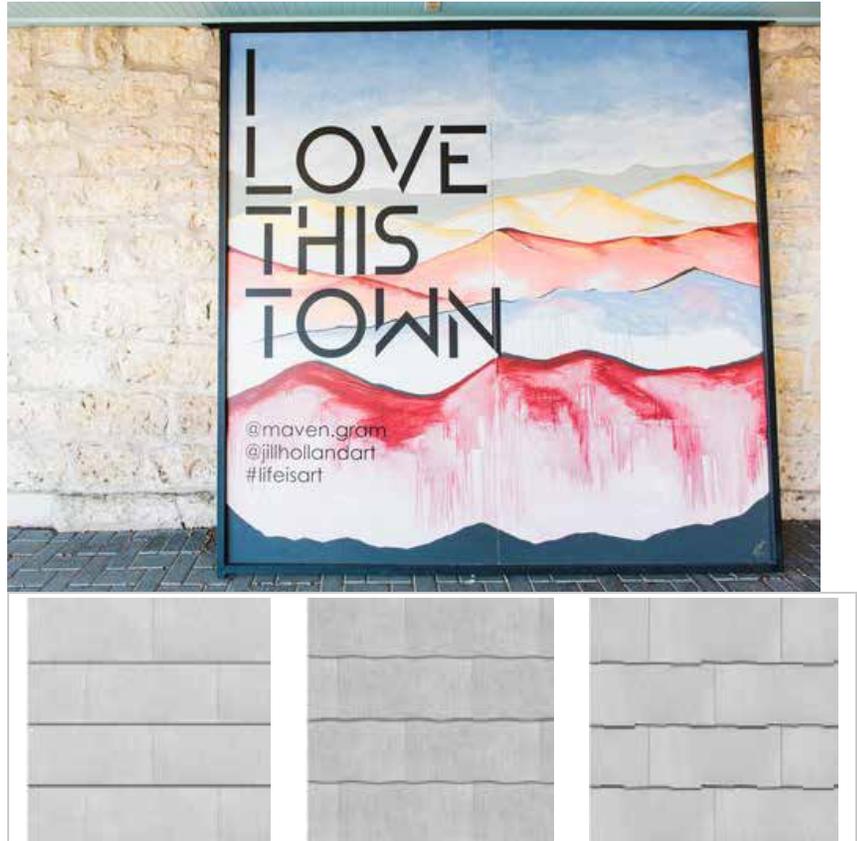
Figure 3-25. Matching replacement siding is just as important for midcentury buildings as older buildings. Fiber-cement shingles may be used to replace asbestos shingles. Although available options for fiber-cement—like these—may not match the original profile and dimension of the asbestos shingles exactly, the closest match available should be selected. Source: “Purity Fiber-Cement Siding,” GAF, accessed January 24, 2021, <https://www.gaf.com/en-us/roofing-products/residential-roofing-products/fiber-cement-siding/siding-shingles/weatherside-purity-fiber-cement-siding>.

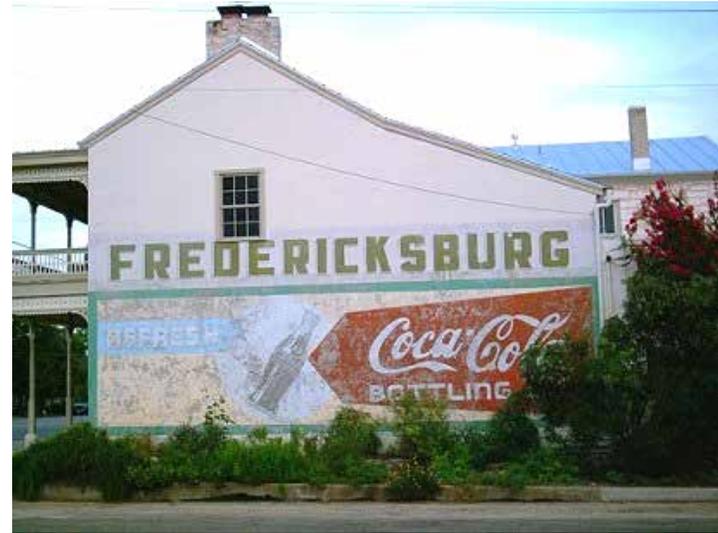
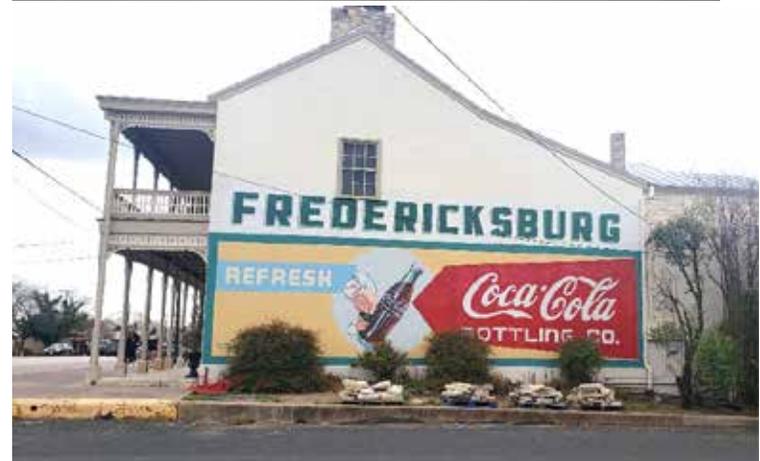
Figure 3-26. Example of a historic mural that has been restored by a local artist. Source: Shannon Yarbrough, “A Coca Cola sign in Fredericksburg” [top photo], from “Fredericksburg, Texas,” Texas Escapes, accessed January 8, 2021, <http://www.texasescapes.com/TexasHillCountryTowns/Fredericksburg-Texas.htm>.

- (m) If restoration of a historic-age mural is necessary, hire a qualified professional conservator (SOI Standard 7).
