3.2.8. Windows and Window Openings

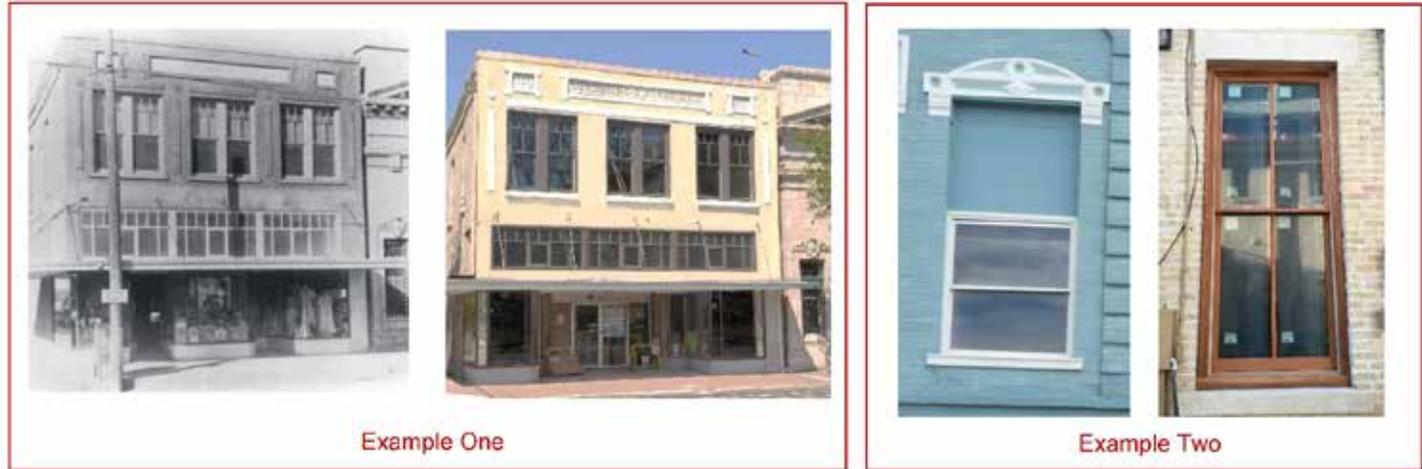
Figure 3-35. Examples of replacement windows for commercial buildings, directly from “Texas Main Street Center Design Topics: Window Repair and Replacement,” Texas Historical Commission, published November 2016, <https://paristexas.gov/DocumentCenter/View/2025/Window-repair-and-replacement?bidId=>.

Example #1: In the example to the right, the original windows were lost. However, replacements were created to match the original windows seen in the historic photos. The new windows were constructed out of a different material, however, the divisions and proportions of the new window match exactly.

Example #2: The second example shows the dramatic difference it makes when the replacement window fits the existing opening. The window on the left was an “off-the-shelf” vinyl window, while the one of the right was created to perfectly fill the opening. This window also recreates the profiles and configuration of the original window, which adds to the overall aesthetic of the window and building.

Example #3: The final example illustrates the difference between compatible and non-compatible windows. The left image depicts replacement windows that are a single dark pane of glass that eliminates the detail and depth that would have been seen in the original windows. Notice how these replacements create voids in the façade, while the windows on the right add to the overall character.

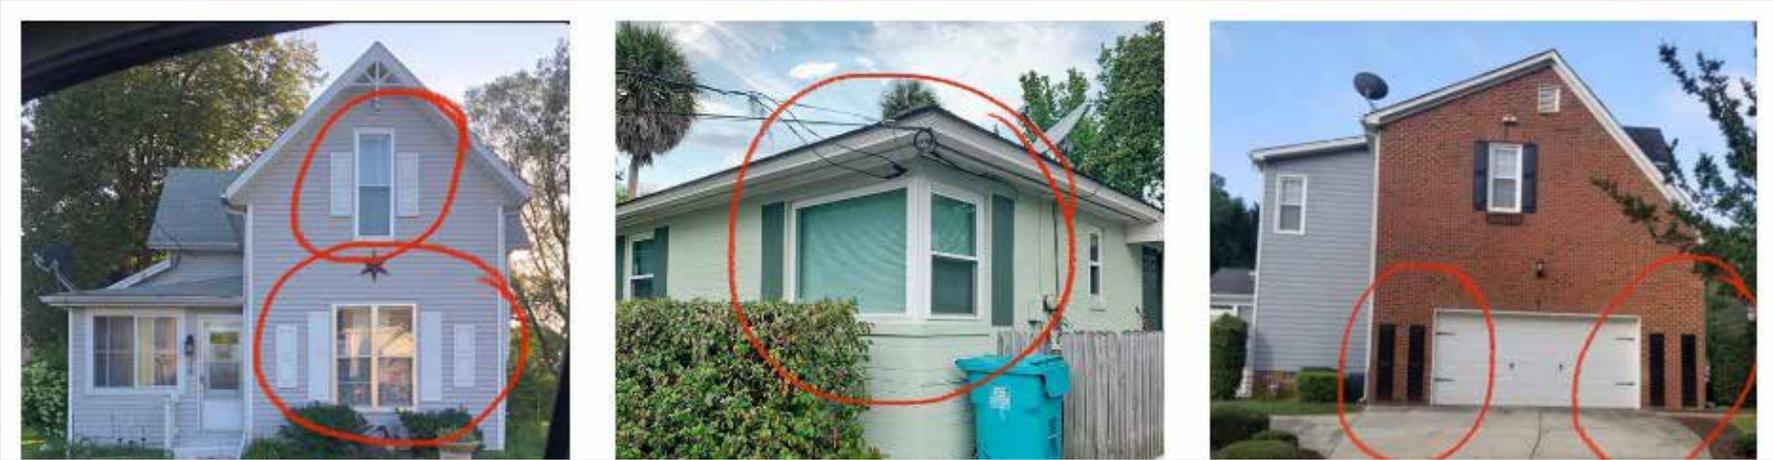
Figure 3-36. Examples of **inappropriate** new shutters improperly sized to fit the original window openings. Source: Scott Sidler, "All About Wood Shutters," The Craftsman Blog, published October 8, 2020, <https://thecraftsmanblog.com/all-about-wood-shutters/>.

To be period-appropriate, new shutters and screens should be sized appropriately to fit the original window opening. If closed, shutters should match the original window width. New shutters and screens on main buildings always should be painted; unpainted or stained shutters and screens are appropriate for auxiliary buildings only. Refer to *Section 2* for examples of period-appropriate shutters and screens.
