### 3.2.5. Porches and Exterior Stairs

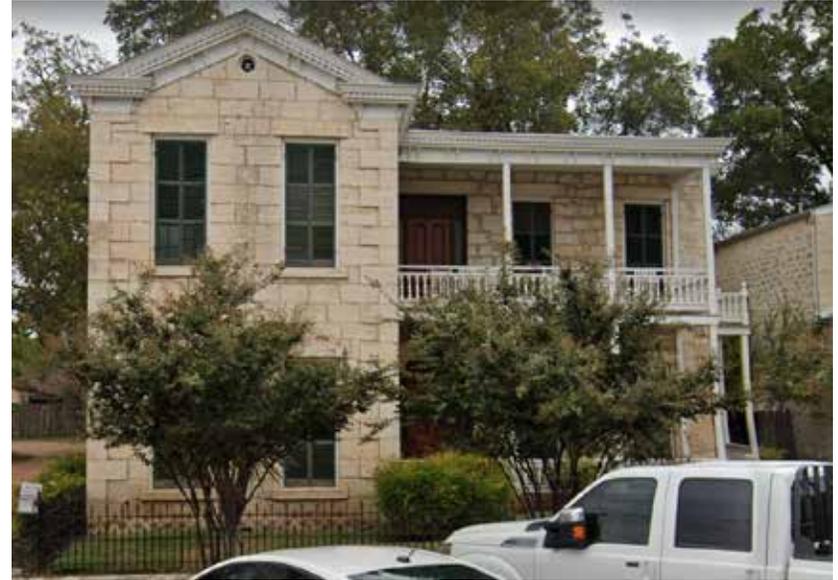
Figure 3-16. Example of an **appropriate** supplemental railing added above a historic balcony railing at 252 E. Main Street. Source: Google Street View.

- (d) If historic porch, balcony, or exterior stair railings do not meet current building codes, work with building code officials to determine if an exception may be possible, especially if the porch or balcony is seldom used. For porches and balconies that remain in use, maintain the historic railing and supplement it with a visually unobtrusive higher rail (SOI Standard 9).
