3.2.3. Roofs and Roof Features

Roof Maintenance

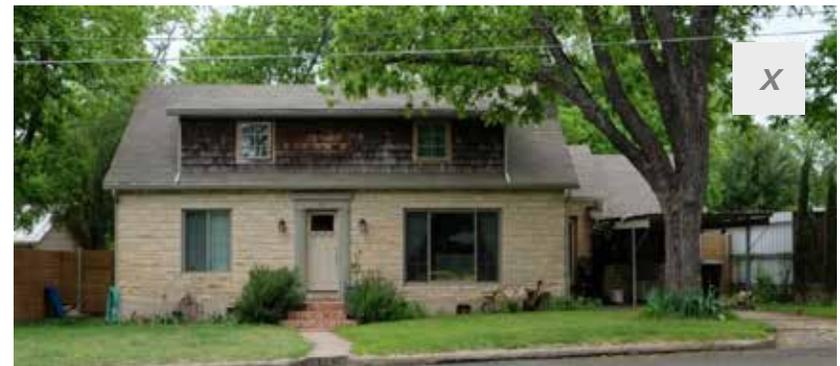
Figure 3-5. Example of a house with an **inappropriate** non-historic dormer altering the original roof form and compromising the integrity of the house. Source: CMEC 2019 Historic Resources Survey.

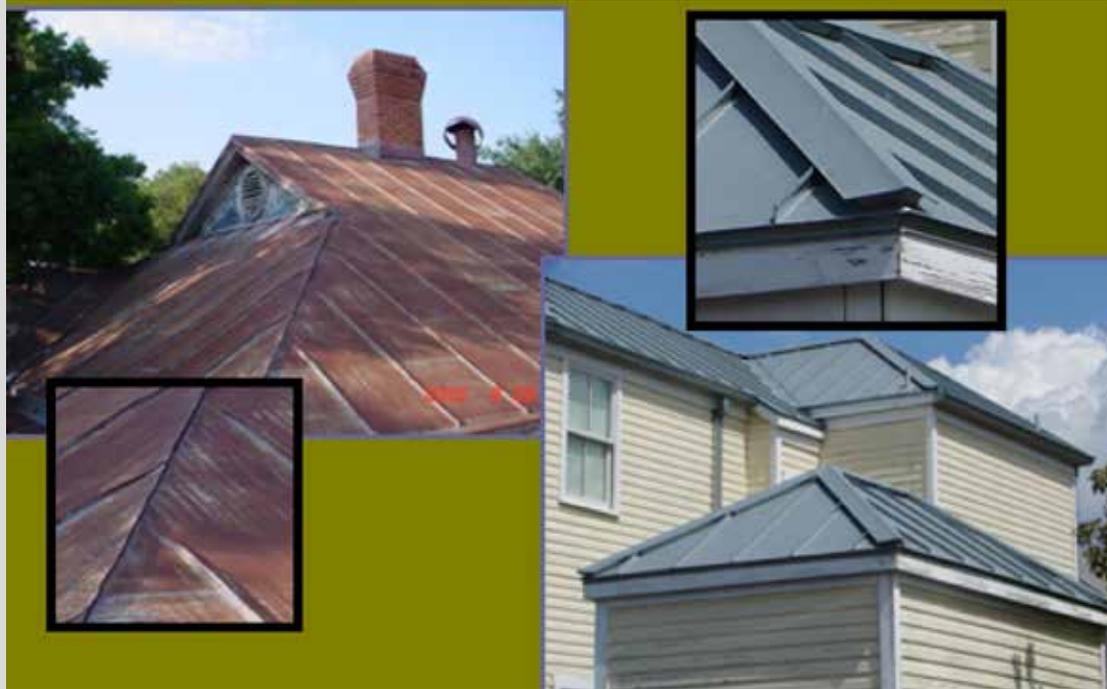
Figure 3-6. Examples of appropriate details for metal roofs. Sources: City of Fredericksburg Historic Preservation Office, SMANCA Architectural Sheet Metal Manual.

The **above** photographs compare details of metal roofs. The example of the reddish roof at the far left uses crimped joints, required for houses built before ca. 1915. The gray roof in the middle example uses a ridge cap, which is not appropriate for this pre-1915 house, but might be appropriate for a post-1915 house.

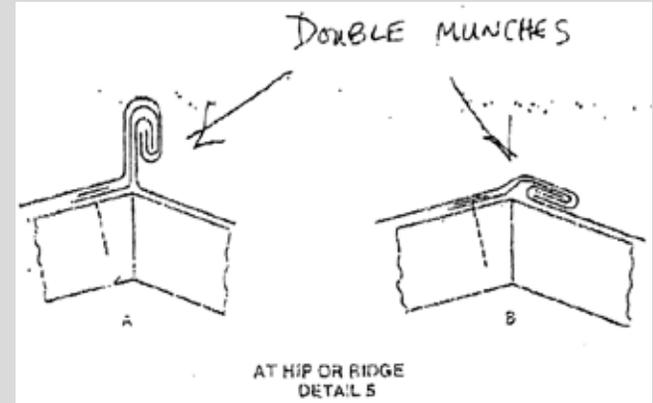
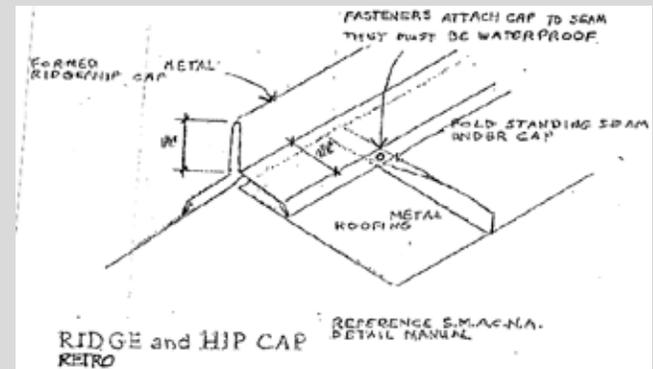
The **top** detail shows a type of folding known as “double munch” appropriate for joints on pre-1915 buildings; the **bottom** detail shows use of a ridge cap, which is acceptable on post-1915 buildings.

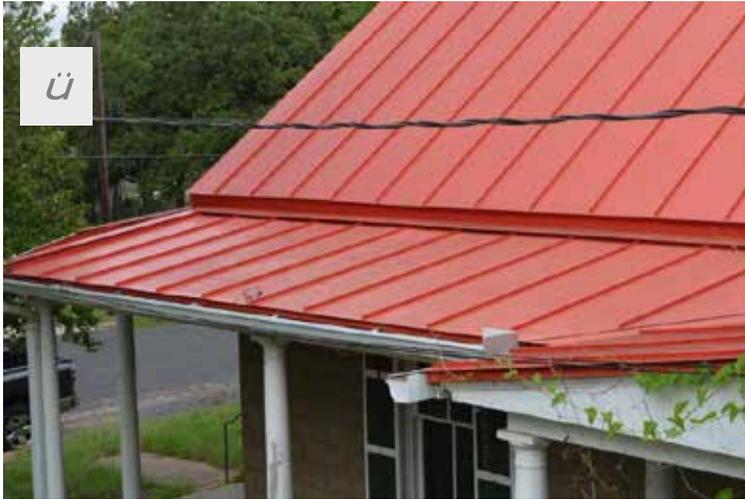
Figure 3-7. Example of a historic integrated gutters and **appropriate** replacement gutter at 408 E. College Street. This example illustrates how water flows from the roof into the original integrated gutter, but the molded profile is preserved at the edge of the integrated gutter. Source: CMEC 2019 Historic Resources Survey.

Some buildings in Fredericksburg feature gutters integrated into eaves or cornice, making them difficult to inspect or access for cleaning and repairs. These gutters often clog or rust, causing leaks

and water infiltration and deterioration of the surrounding historic materials. Replacement of faulty integrated gutters is appropriate in all instances, provided that the replacement generally maintains the profile and finish of the eaves or cornice. Damage to surrounding historic fabric should be minimized during removal of the integrated gutters and installation of new gutters. (See fig. 3-5.)

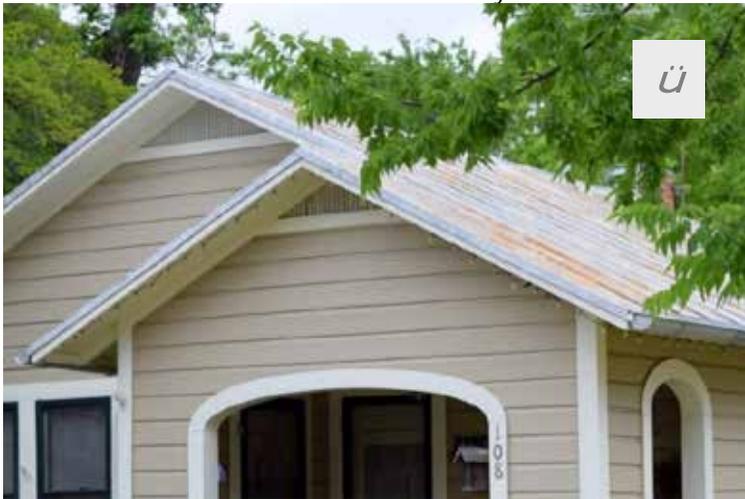
Figure 3-8. This example shows a detail of an **appropriate** half-round gutter at 108 W. College Street. When replacing a failing integrated gutter, consider application of a similar curved gutter, or a gutter that mimics the profile of the original gutter as closely as possible. Source: City of Fredericksburg.

- (n) When replacing failing integrated gutters, using half-round external gutters may help preserve the historic profile of the cornice (SOI Standard 6).

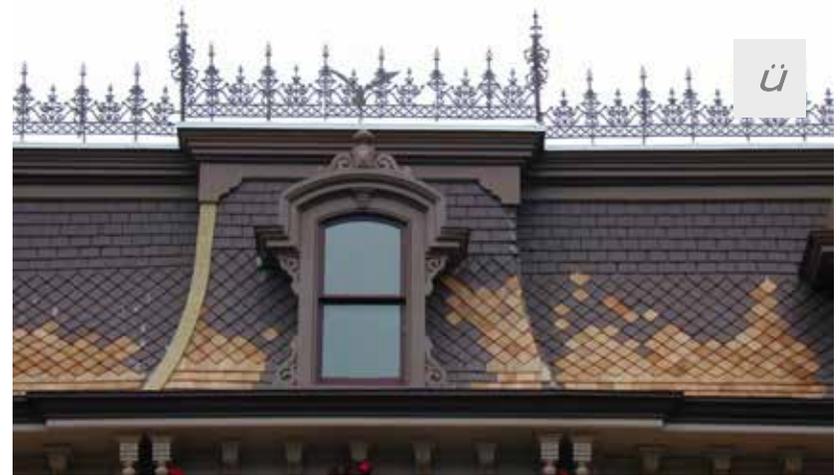
Figure 3-9. Example of a wood-shingle roof in San Antonio, with **appropriate** patching of only the area deteriorated beyond repair. Source: Winter & Company.

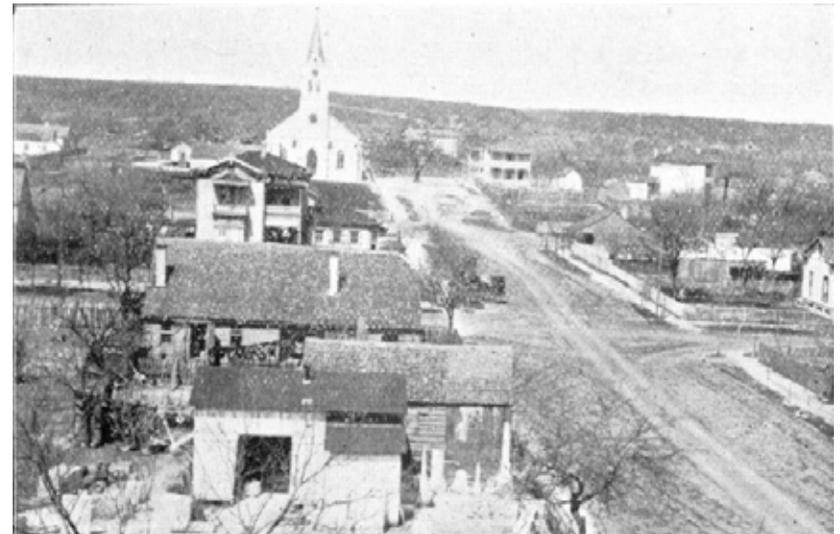
Figure 3-10. Bird's-eye view photo of Fredericksburg from 1896 showing wood shingles present on most roofs. Source: Robert Penniger, *Fest-Ausgabe zum 50-Jährigen Jubiläum der Gründung der Stadt Friedrichsburg* [book], n.p., 1896, from the Portal to Texas History crediting the University of Texas at Arlington Library, <https://texashistory.unt.edu/ark:/67531/metapth29396>

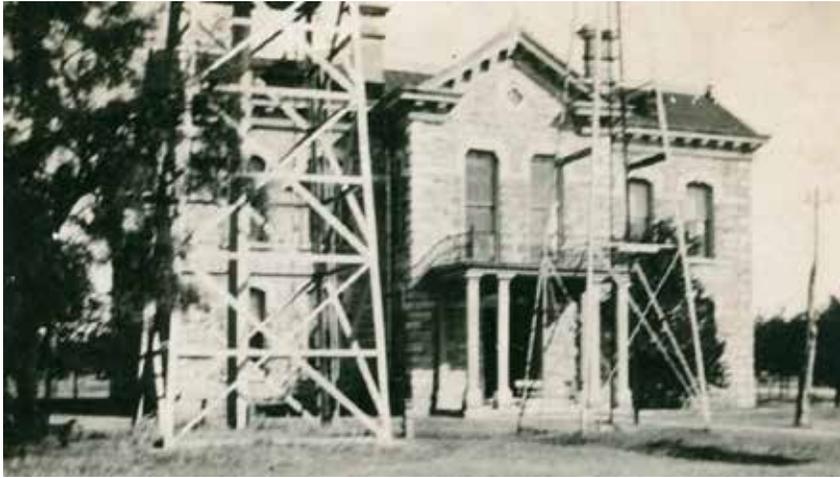
Figure 3-11. Photo of the Fredericksburg courthouse (now the Pioneer Memorial Library) in 1911, showing a metal roof. This substantial public building was constructed in 1882 and designed by prominent architect Alfred Giles. Source: [Photograph of a Courthouse in Fredericksburg, TX], n.p., 1911, from the Portal to Texas History, crediting the Gillespie County Historical Society, <https://texashistory.unt.edu/ark:/67531/metaph245986>.

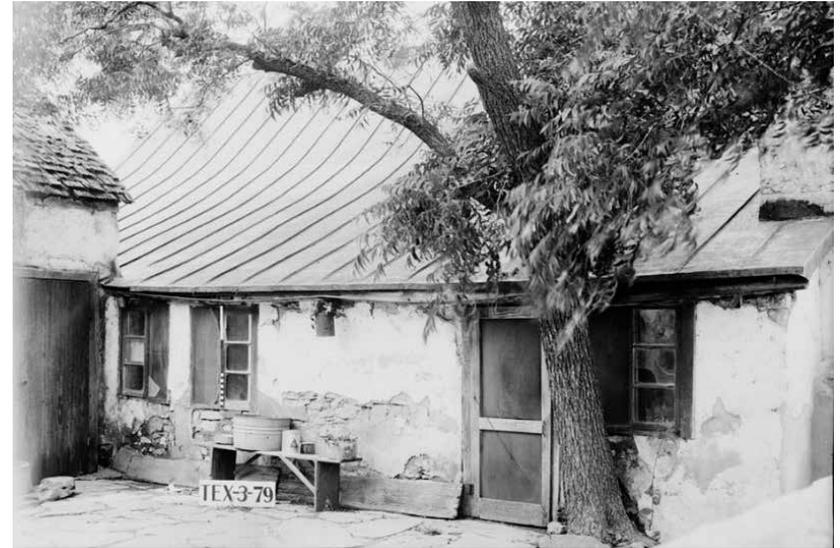
Figure 3-12. Photo of the Heinrich Kammlah House, 309 W. Main Street, showing wood shingles on the older portion of the house (seen on the left), juxtaposed to standing-seam metal roofing on a historic-age addition. Source: Library of Congress, HABS, ca. 1930, <https://www.loc.gov/item/tx0336/>. Find additional HABS photos showing a combination of metal and wood shingle roofs at <https://www.loc.gov/pictures/search/?q=fredericksburg>.

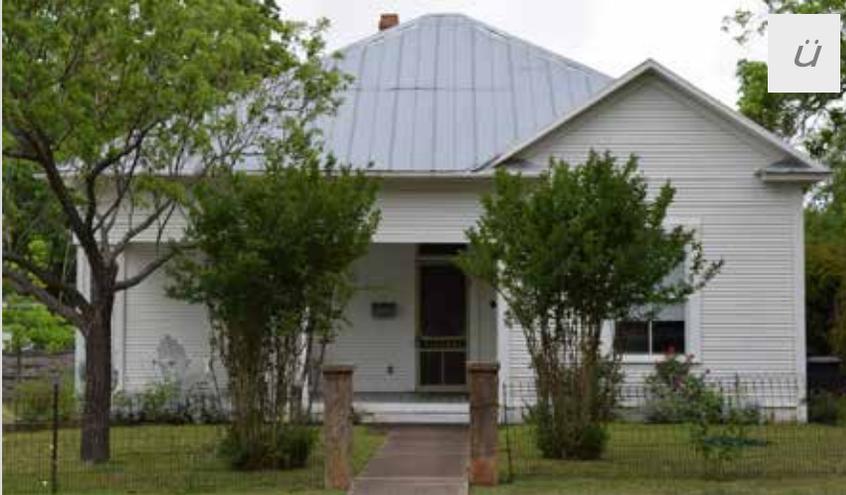
Figure 3-13. Examples of **appropriate** versus **inappropriate** use of metal roofs. Sources: CMEC 2019 Historic Resources Survey, City of Fredericksburg.

The example **above** at 303 W. College Street shows the **appropriate** use of a metal roof with folded joints. Given the house's National Folk style, a metal roof was likely original. Because the house was constructed ca. 1910, use of folded or crimped joints is required.

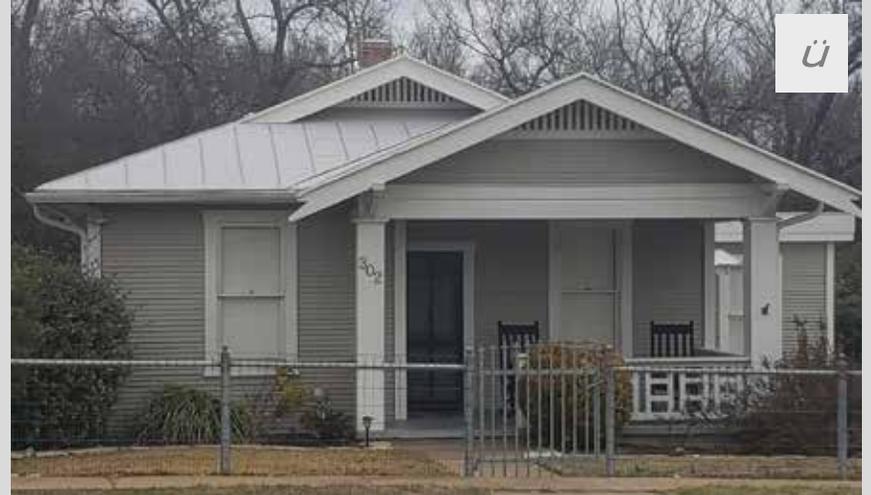
The example **above** at 302 W. Austin Street shows an **appropriate** application of metal roof. Even if the original roof was not documented to be metal, roof material typically is not a character-defining feature for a Craftsman house like this. Crimping is appropriate—though not required—even though this house was constructed ca. 1920.

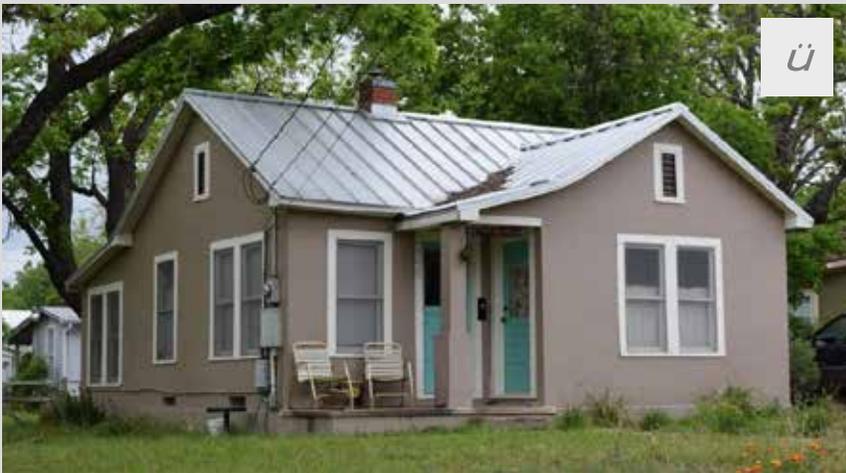
The **above** example of a new metal roof at 402 N. Milam Street is **appropriate in this case** because the house has no style, so the original roof materials were not character-defining. The ridge cap is appropriate given the ca. 1940 date.

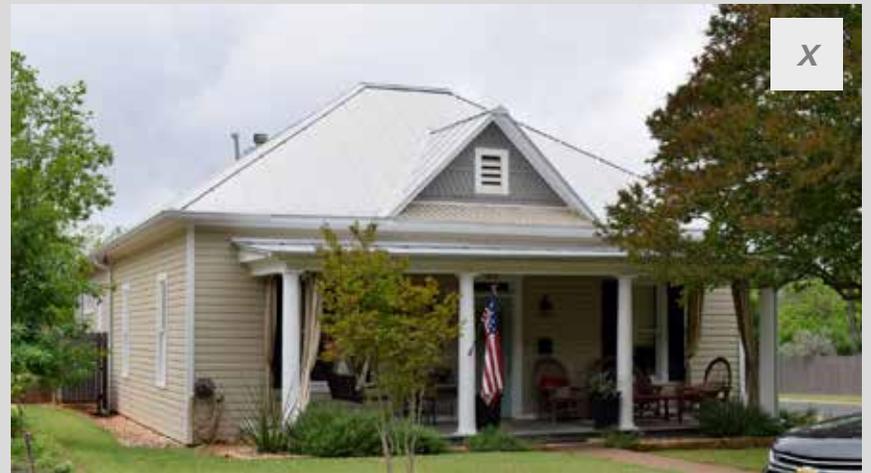
The example **above** at 313 W. College Street shows the **inappropriate** use of a ridge cap rather than folded or crimped joints given the house's construction date of ca. 1910.
